# FCRPS BiOp Implementation

Trout Creek, Klickitat County,  
Washington

## Hemlock Dam removal and Trout Creek restoration project

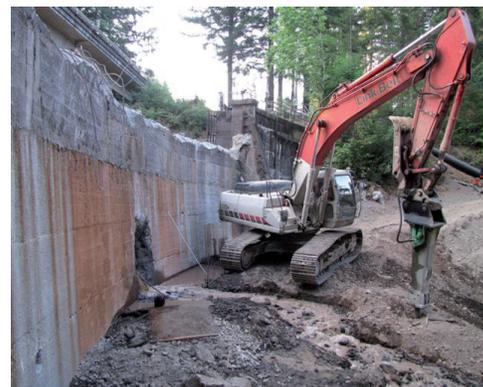
The first hole being knocked in Hemlock Dam

The culmination of the Hemlock Dam Removal Project happened quietly. At 5 a.m., Aug. 3, an excavator with a hammer attachment punched the first hole in the concrete. No torrent of water blasted through from a pent-up reservoir. All the water in Trout Creek, part of the Wind River watershed of southwest Washington, was already being pumped around the site through a half mile of pipe.

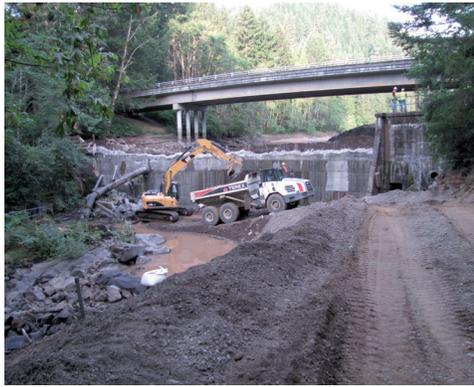
Halfway through the dam removal process.

Twenty four hours later, the dam was completely gone. The pumps were turned off and the creek was re-watered. Just hours later, a video camera captured an adult steelhead swimming up the newly re-formed creek.

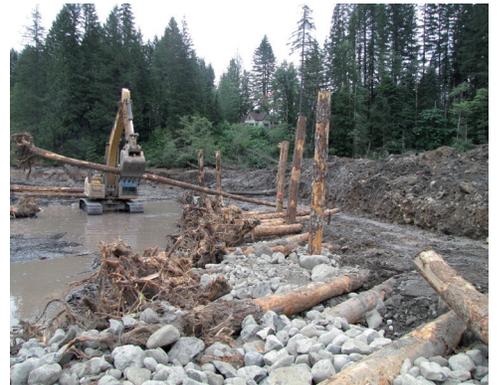
Workers scattered the reconstructed channel with tree trunks and placed stumps of mature trees with root balls intact throughout the floodplain to mimic the standing and fallen trees that the creek washed around.

They scattered the reconstructed channel with tree trunks, simulating the fallen logs that helped establish the historic path of the river. They erected stumps of mature trees with root balls intact throughout the floodplain to mimic the trees that the creek washed around during heavy rains.
