Figure 4a. Estimated change in non-forest surface erosion rate from historical conditions in the Columbia River basin.

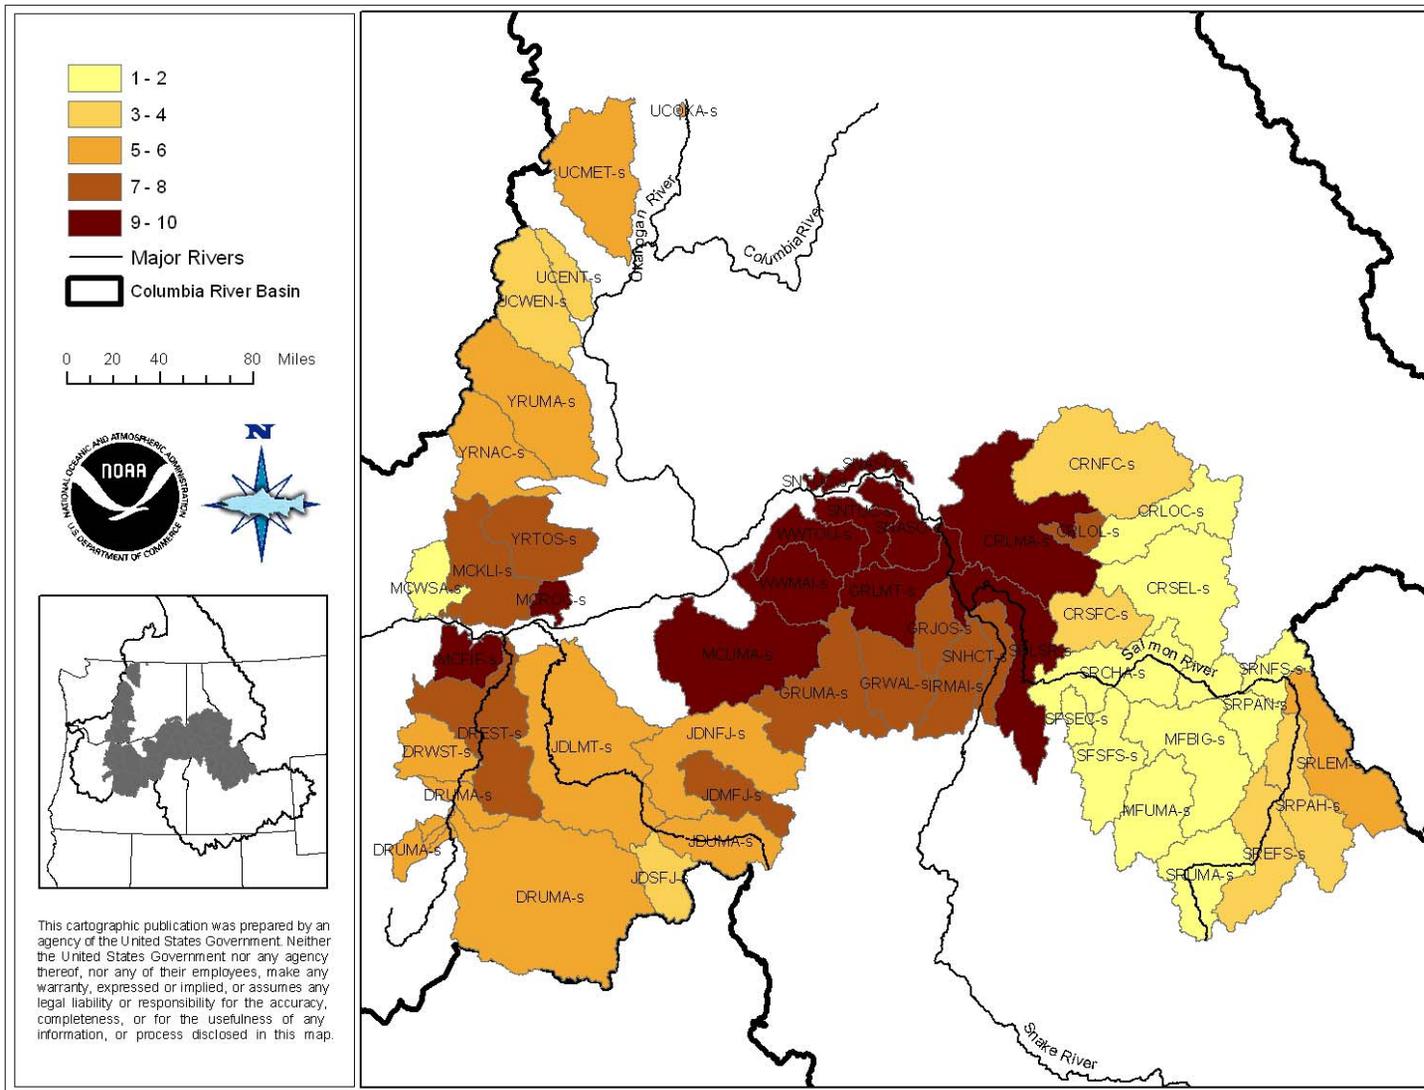
Figure 4b. Estimated change in non-forest surface erosion rate from historical conditions for steelhead populations.

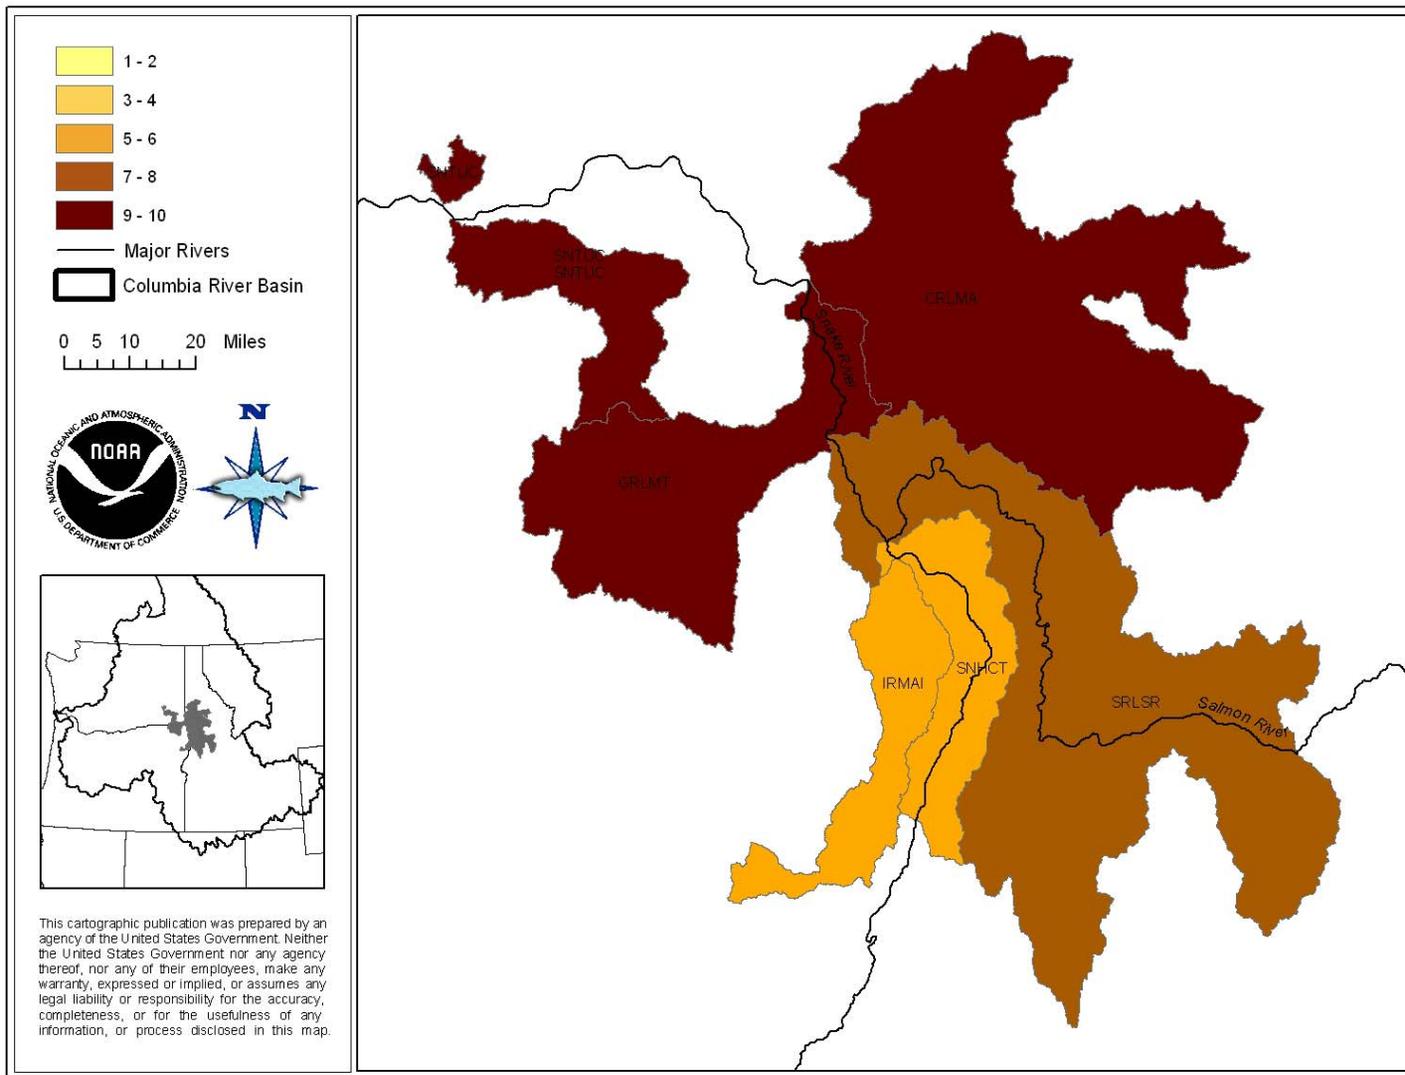
Figure 4d. Estimated change in non-forest surface erosion rate from historical conditions for fall chinook populations.

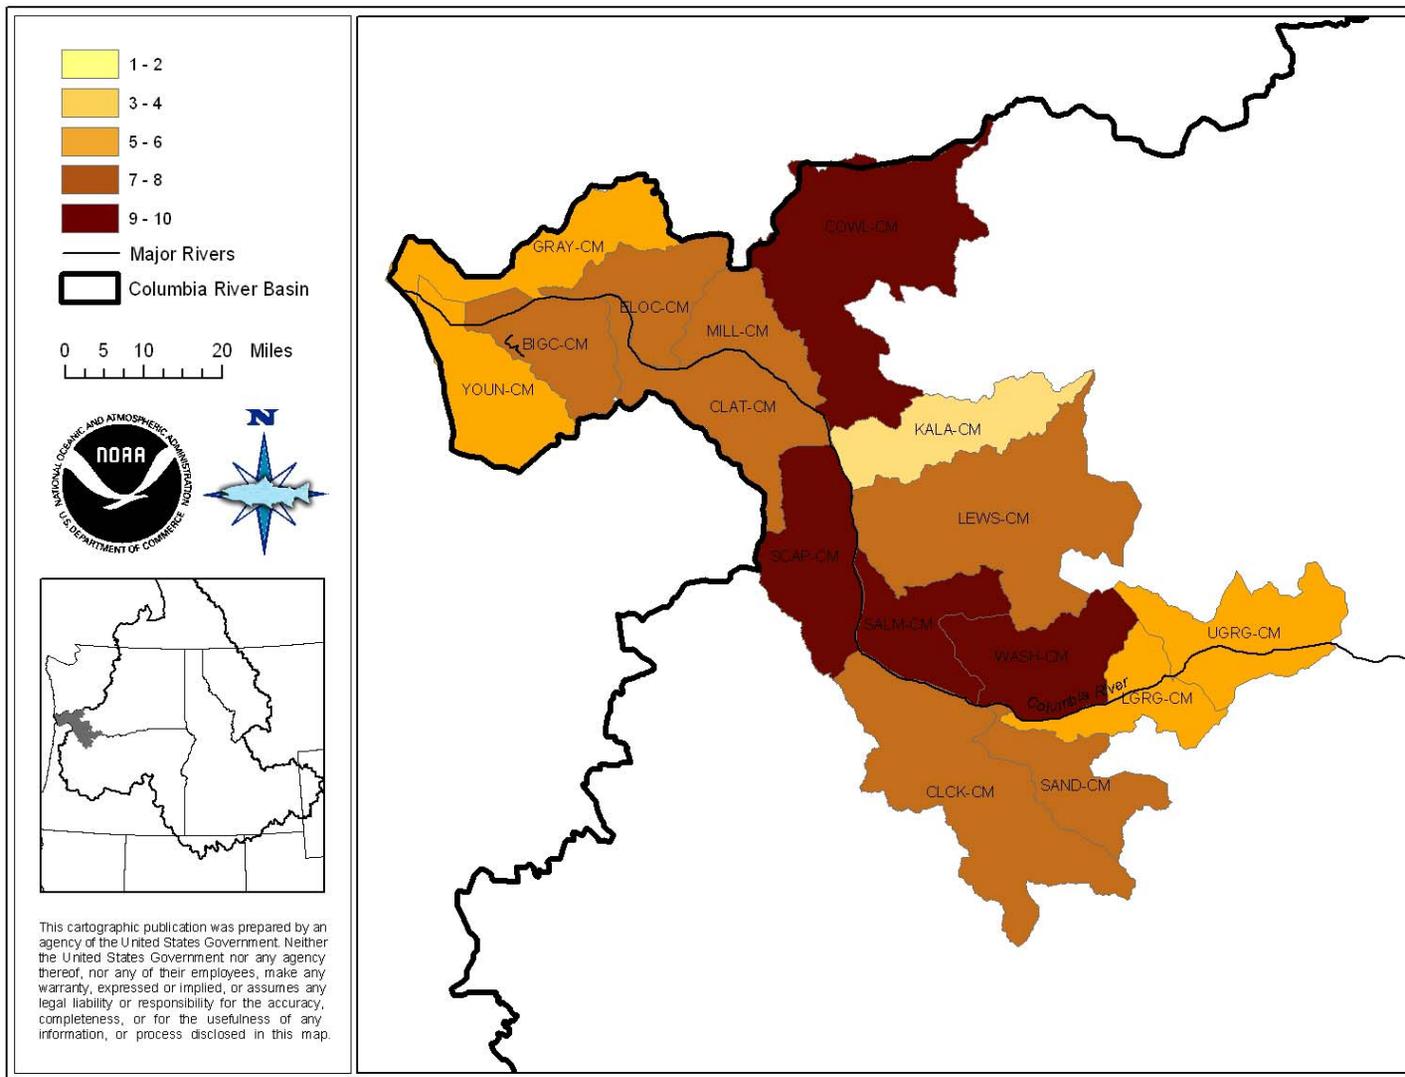
Figure 4e. Estimated change in non-forest surface erosion rate from historical conditions for lower Columbia chum populations.
