More Fish Use Reconnected Side Channel near Elbow Coulee

Methow River, Washington

Bureau of Reclamation

May 2013

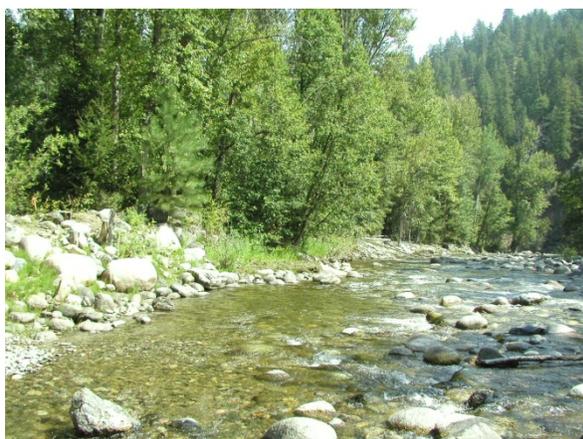
1)

Photo 1. Levee at river left along Twisp River conceals the side channel with extensive floodplain rearing habitat. Photograph was taken in summer 2008 looking east.

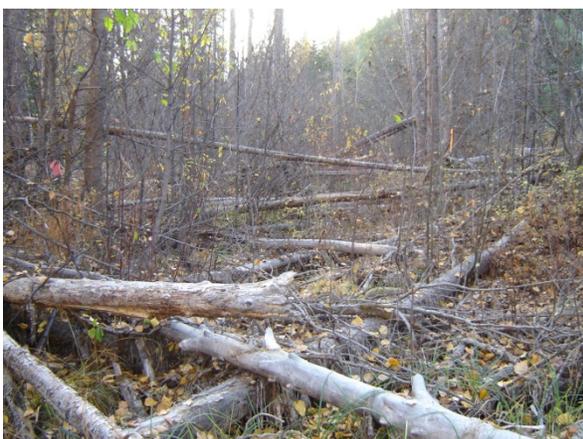
2)

Photo 2. Disconnected side channel showing numerous downed trees and woody vegetation. Photograph was taken in 2006 looking down-gradient viewing northeast.

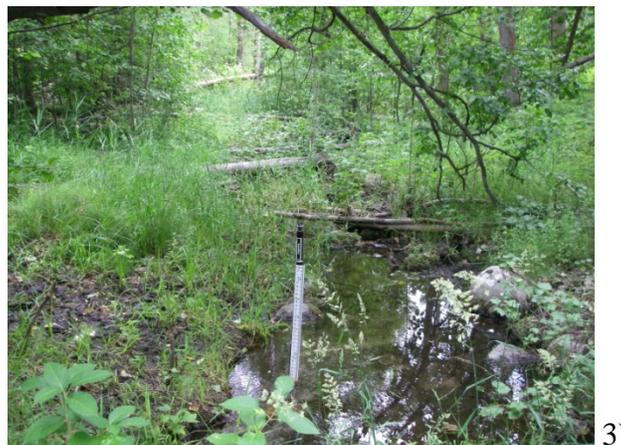
3)

Photo 3. Before the project, this previously groundwater fed side channel had a terminal connection to the Twisp River. A levee was breached at the upstream end of the Elbow Coulee side channel along the left bank of the Twisp River in Fall 2008. A monitoring program was soon initiated in the side channel, which received its first flows from the Twisp River in 2009 during the spring freshet. The photograph was taken in summer 2008 looking northeast down gradient.

The perennial nature of groundwater inputs provide at least 700 linear feet of rearing habitat for fish including spring Chinook salmon and steelhead, along the entire length of the baseflow wetted channel (Crandall, 2009) (Photo 3). The perennial groundwater provides year-round downstream connectivity to the Twisp River and monitoring results indicate juvenile fish are using the side channel for rearing.

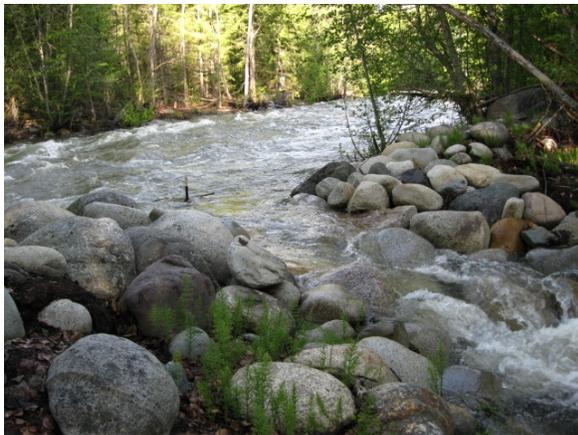
4)

Photo 4. View looking west and upstream of the side channel confluence with the Twisp River and the reconstructed inlet of the side channel. The view shows side channel activation during high water May 2010.

Twisp River flows greater than approximately 580 cfs are sufficient to crest the rock sill in the breach and fish would have uninhibited passage into the upstream end of the side channel (Crandall, 2009) (Photos 4 – 5). Once in the side channel, fish would have the ability to move downstream within the side channel and also back into the Twisp River at the terminus of the side channel. Thus, flows in excess of 600 cfs are sufficient to allow passage for all life stages of fish. Due to the extended length of activation this last year, fine sediment and smaller particles were flushed out of the breach and it is expected to activate at a lower discharge (Crandall, 2011, unpublished communication). This will be confirmed in 2012 during the winter/spring flows. This adjustment is a natural outcome of a system allowed to freely adjust and settle out.

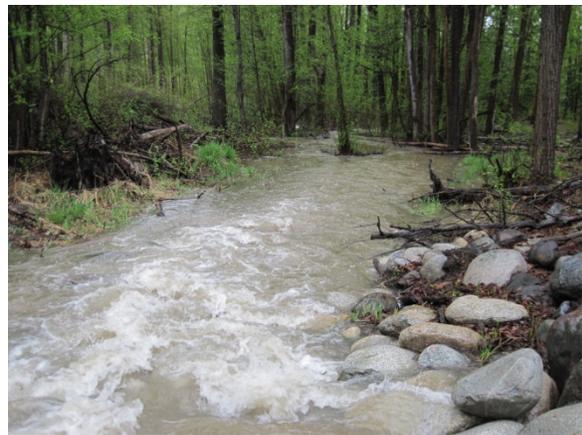
5)

Photo 5. The same event as Photo 4, downstream view of the activated side channel looking northeast during high water spring 2010.

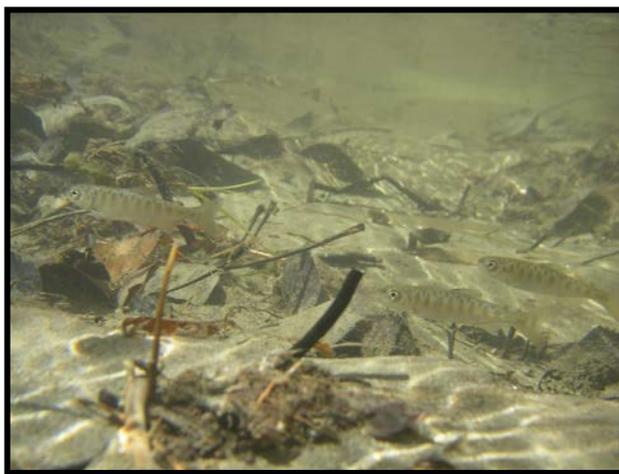
6)

Photo 6. Endangered spring Chinook salmon, *Oncorhynchus tshawytscha*, in the Elbow Coulee side channel during the first post-construction spring channel activation event, June 2009.

In late 2008, 42 fish representing three species were captured and identified during an electrofishing survey (Figure 2). Fish were captured along the entire length of the wetted channel and were most commonly observed in the deeper portions of the channel in pools (Crandall, 2009) (Photo 6). A subsequent electrofishing survey in late 2011 recorded an almost three-fold increase from 2008 in fish abundance and a greater diversity of fish species present in the side channel.

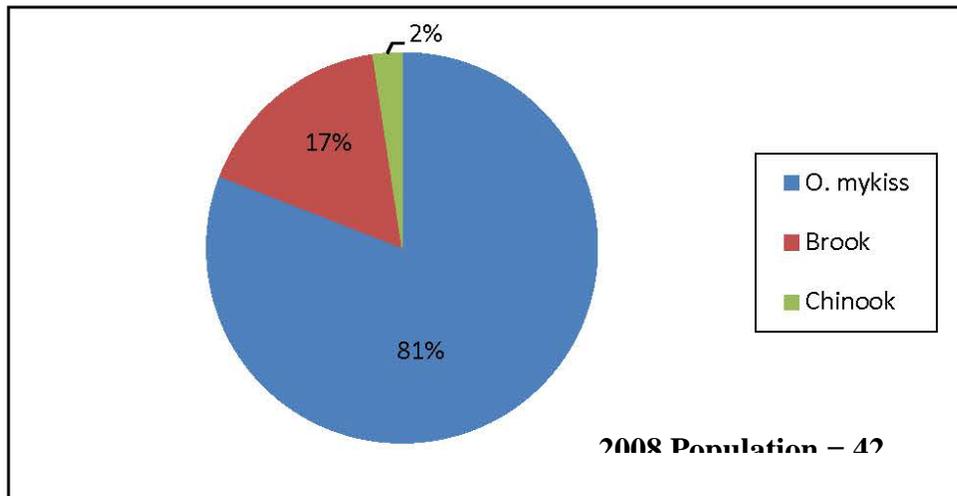
Figure 2.a. Elbow Coulee side channel fish species composition data for **2008**. Forty-two fish representing three species were sampled. Rainbow trout/steelhead dominated the catch representing 81 percent of the total. While present, ESA-listed spring Chinook were represented by only one individual. Non-native brook trout comprised 17 percent of the catch.

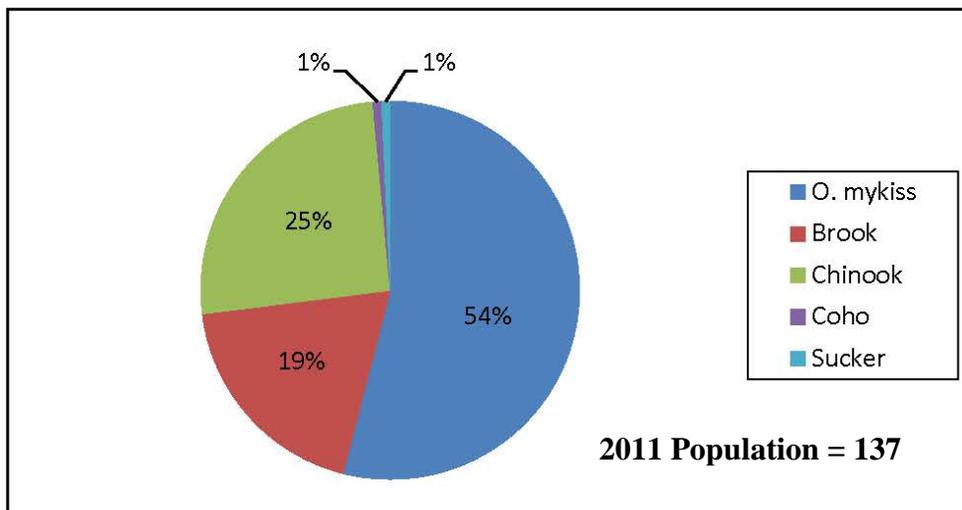
Figure 2.b. Elbow Coulee side channel fish species composition data for **2011**. There was a three-fold increase in fish abundance in the side channel after three years of flow activation via the Twisp River when compared to 2008. Species richness also increased with the addition of coho salmon and bridgelip sucker. ESA-listed abundance increased noticeably. Spring Chinook salmon abundance increased from 1 to 48 and rainbow trout/steelhead increased from 34 to 74.

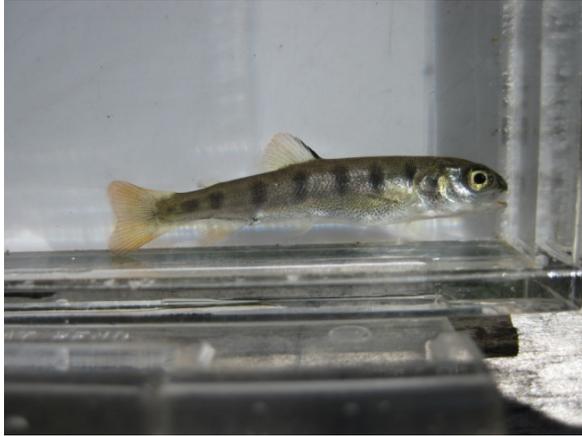
7)

Photo 7. A rearing wild young-of-the-year rainbow/steelhead trout collected from the side channel during May 2010.

While rearing-sized fish were observed in the side channel prior to reconnection, the presence of young-of-the-year fish, including ESA listed salmonids, in the uppermost pool in the side channel is strong evidence that these fish gained access to the side channel through the newly constructed breach (Photos 7 – 8). Although it is plausible that 40 mm salmonids could have gained access to and entered the side channel from the bottom, the presence of larval sculpin (less than 20mm) that lack the swimming ability to move upstream through the side channel, is evidence that fish are entering the side channel through the newly created breach. Thus, it was concluded that fish gained access to the side channel during the first activation event post-emergence and resided in the channel (Crandall, 2009). Based on observations, the period of fish residency is estimated at several weeks to months and possibly longer for fish that select to remain in the groundwater influenced portion of the channel. Future monitoring will focus on determining whether undesired stranding is occurring and whether the channel may begin to prematurely fill in with fine sediment and detritus.

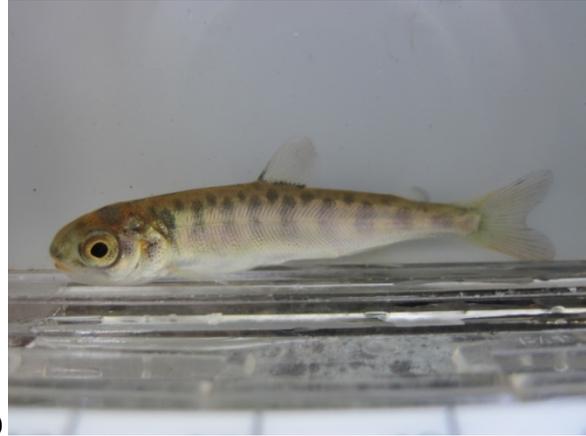
8)

Photo 8. A rearing wild spring Chinook parr, obtained from the side channel during May 2010.

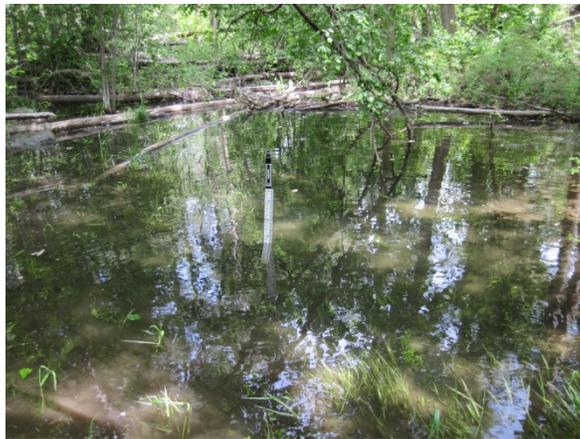
9)

Photo 9. Pond habitat in July 2011 on the activated side channel created by a beaver dam construction just downstream of the flow monitoring site established in early 2009. Note that photo location is identical to Photo 3.

In 2011, beaver constructed two dams just downstream of the flow monitoring site in the side channel (Photos 9 – 10). While the ponds that resulted from this activity disrupted the continuous flow monitoring instrumentation by flooding the area, listed fish species were observed using the ponds almost immediately (Molesworth, USBR, pers. comm.). This change in habitat type has increased habitat complexity within the channel through increased pool habitat, wetted width and large woody debris.

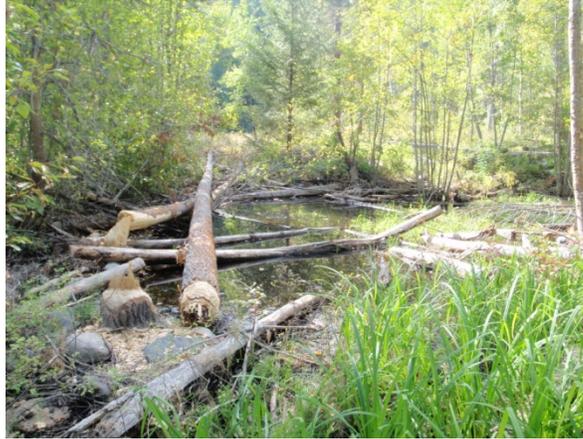
10)

Photo 10. Beaver dams built in 2010 resulted in two ponds within the side channel that were subsequently inhabited and used for rearing by listed fish species.
