# Figure 1

## PAHSIMEROI RIVER PROJECT AREA

This sketch shows conditions BEFORE PROJECTS (2007-2009)

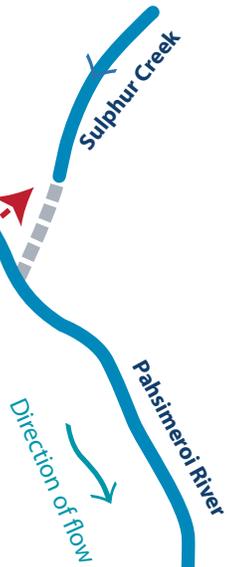
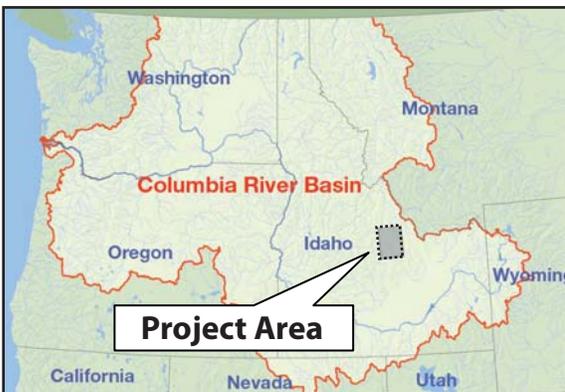
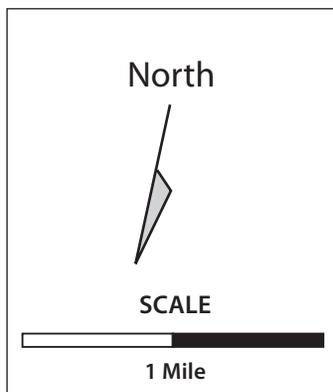
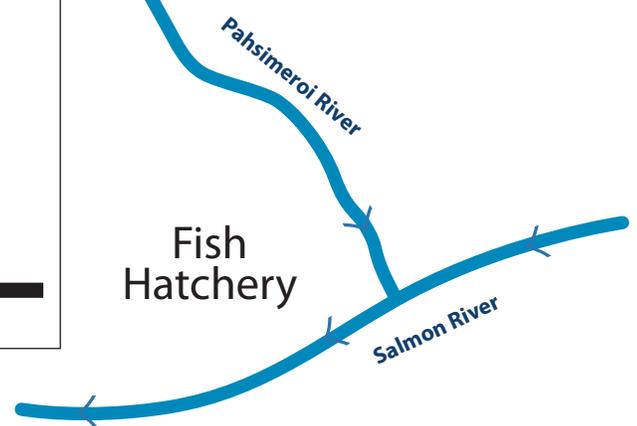
Sulphur Creek was blocked in this area

Duck Creek was blocked at Cross Ditch

Muddy Springs Creek was blocked at P-9 Ditch

Flow in this area was very low: 2 to 5 cfs

Redds above Cross Ditch: 2 in 2008
